# **INDOOR AIR QUALITY ASSESSMENT**

**Powder House Community School  
1060 Broadway  
Somerville, MA 02144**

Prepared by:  
Massachusetts Department of Public Health  
Center for Environmental Health  
Bureau of Environmental Health Assessment  
Emergency Response/Indoor Air Quality Program  
February 2005

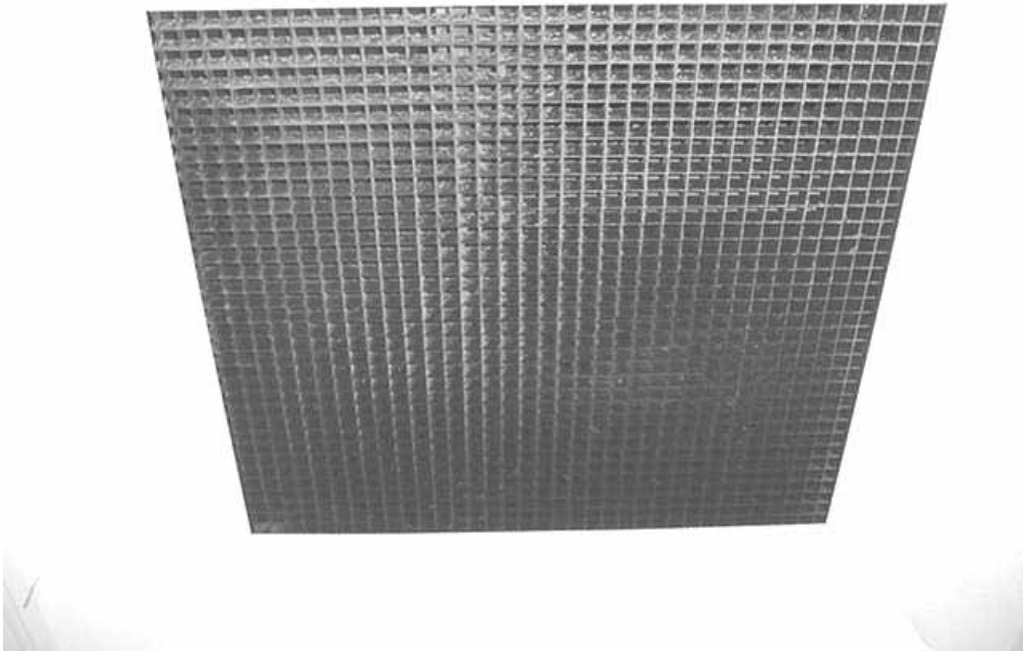
**Picture 2**

**Exhaust vent; note dust accumulation**

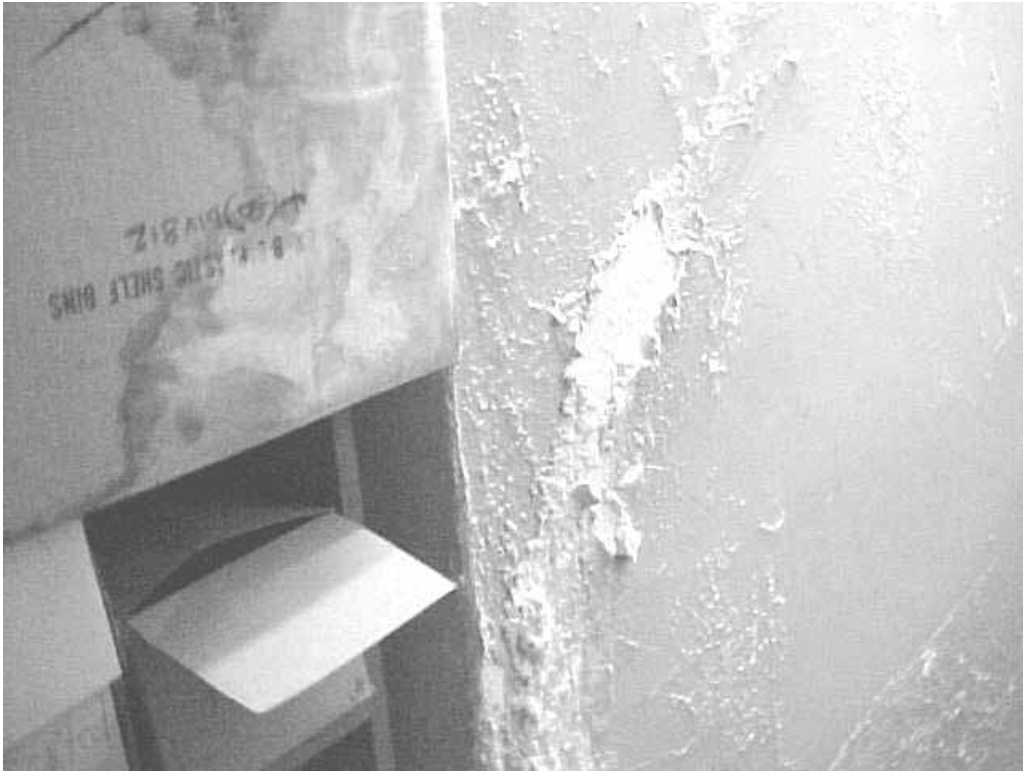
**Picture 3**

storage room is located at the rear of the building, near the adjoining building. Prior to the assessment, BEHA and Mr. Ciampi discussed the extent of water damage experienced in this particular room. During the course of these conversations, Mr. Ciampi provided a photograph of the area in question (Picture 3), and BEHA staff recommended that water damaged materials (e.g. corrugated boxes) be removed and discarded. At the time of the assessment, BEHA staff noted water damaged materials and boxes had been removed from the art storage room; however, remnants of cardboard from water damaged boxes remained adhered to two walls (Picture 4). Efflorescence was also noted on the wall (Picture 4). Efflorescence is a characteristic sign of water damage to building materials such as cement or plaster, but it is not mold growth. As moisture penetrates and works its way through exterior wall, water-soluble compounds dissolve, creating a solution. As the solution moves to the surface of the interior wall, water evaporates, leaving behind white, powdery mineral deposits. This condition indicates that water from the exterior is penetrating the building. The source of moisture also wetted cardboard boxes, which can support mold growth. During the assessment, BEHA staff recommended that the walls be cleaned and disinfected with a bleach and water solution, followed by a soap and water solution.

**Water damaged wall and boxes in Art Storage Room  
(provided by Robert Ciampi: 2/20/2004)**

3. Remove cardboard adhered to walls in art storage room. Clean and disinfect area with a bleach and water solution, followed by a soap and water solution.

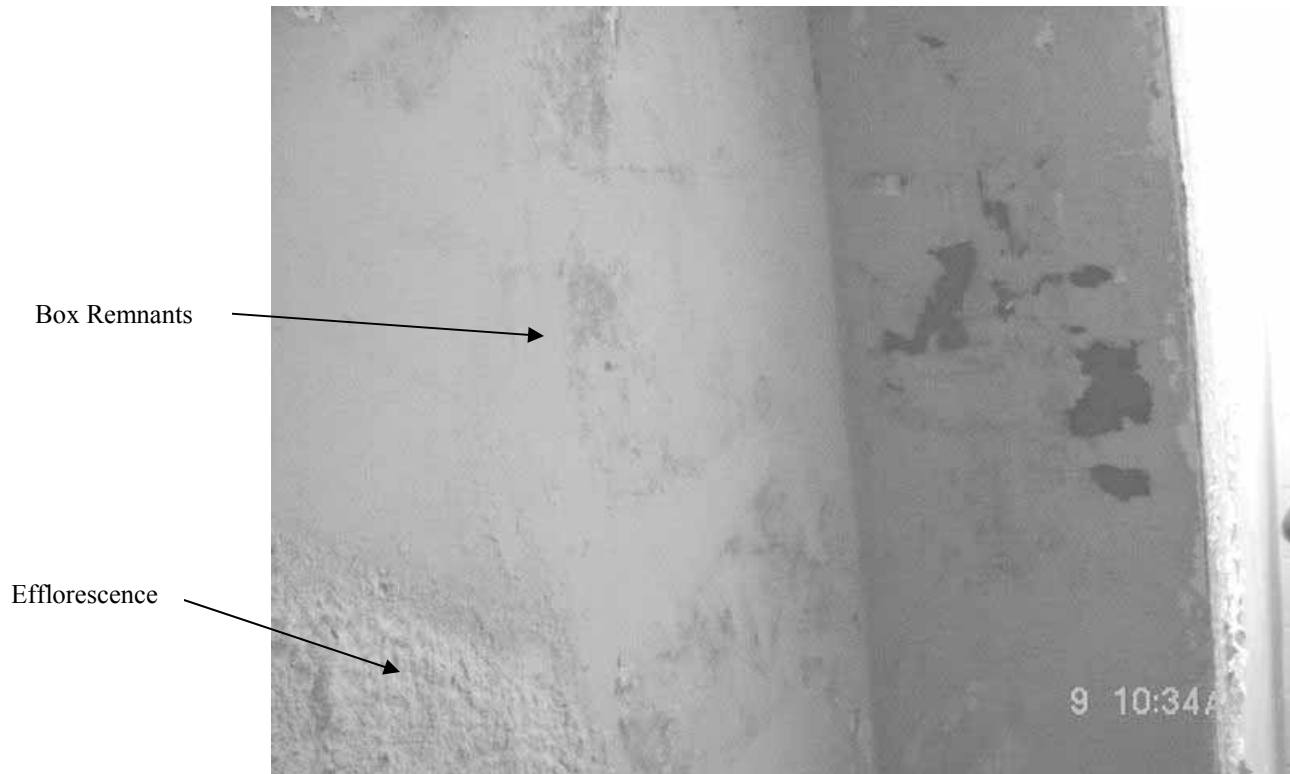
**Picture 4**

**Box remnants and efflorescence on Art Storage Room Wall**

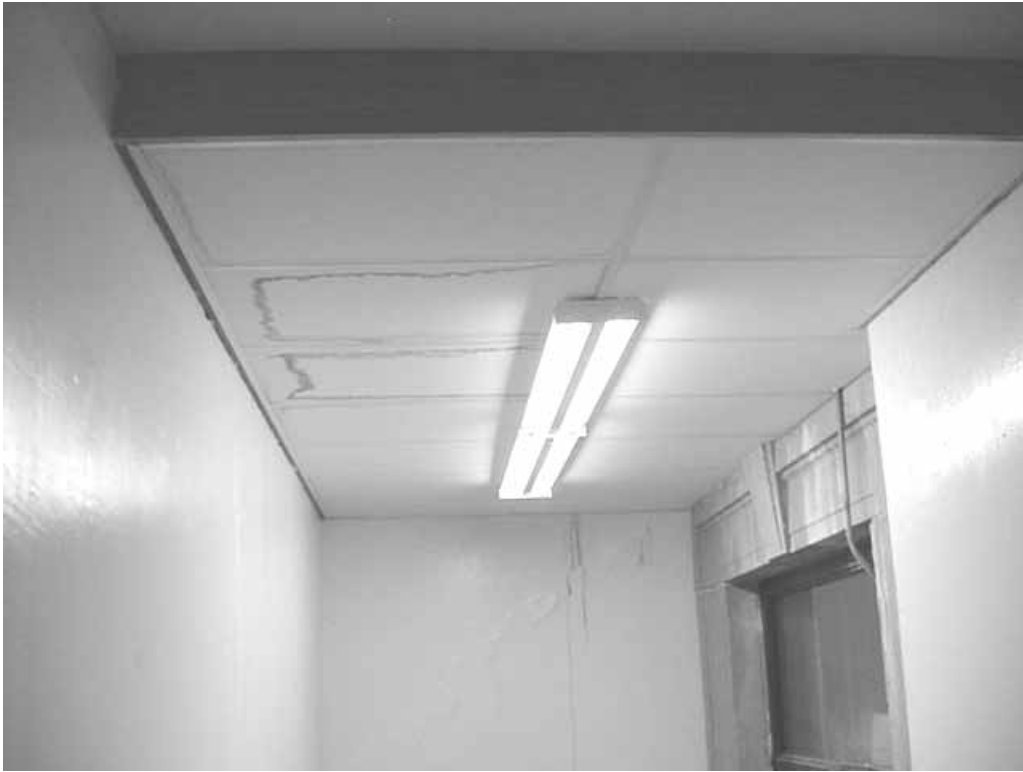
**Picture 5**

Significant water damage was observed on wall and ceiling plaster, as well as on ceiling and floor tiles in the second floor stairwell adjoining the administration building

(Pictures 5 to 7). Water damage was also noted around the doorway leading to the neighboring building (Pictures 8a and 8b). Much of the damage is on the ceiling and upper wall, which suggests a roof leak exists. Building materials in the stairwell connecting the PHCS and the TAB may also be degraded because of age. Moreover, the stairwell is located in a corner where wind often drives rain into the building. Driving rain, especially, can degrade and penetrate a building. The aforementioned stairwell is also located above the Computer Storage Room. Since water damage was noted on the floor of the stairwell, water may likely be penetrating to the level below. For example, efflorescence noted on support columns in the computer storage room may be the result of water penetration from the above stairwell.

**Water damage in stairway near adjoining administration building**

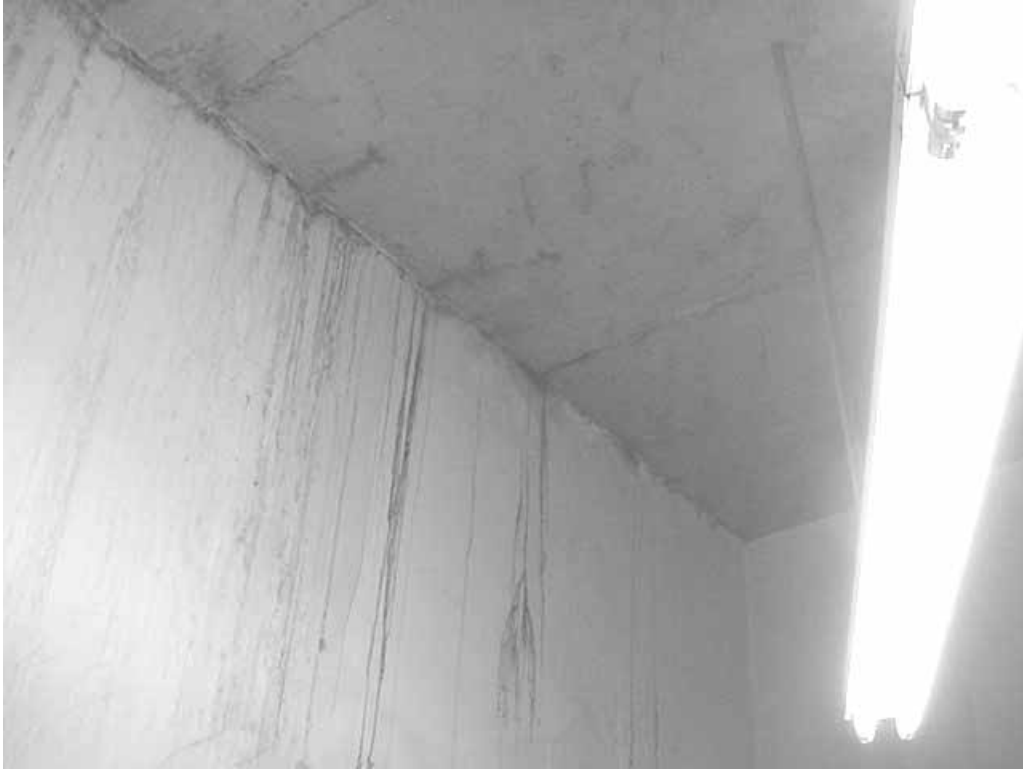
**Picture 6**

**Water damaged ceiling and wall plaster**

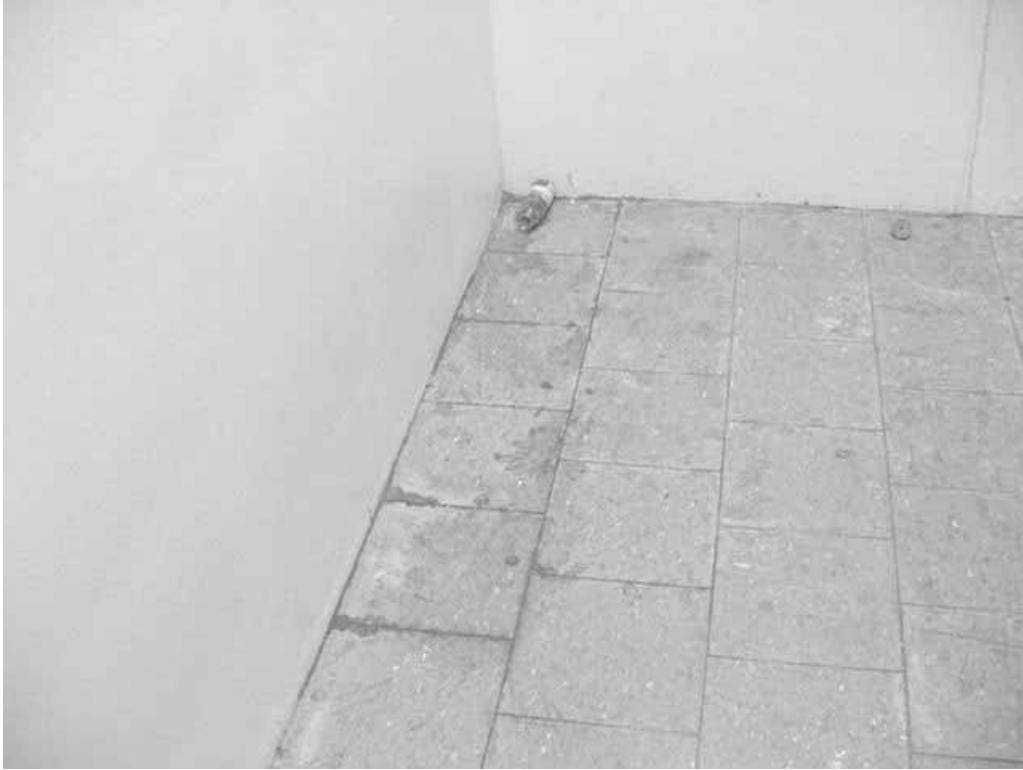
**Picture 7**

**Water damaged floor tiles**

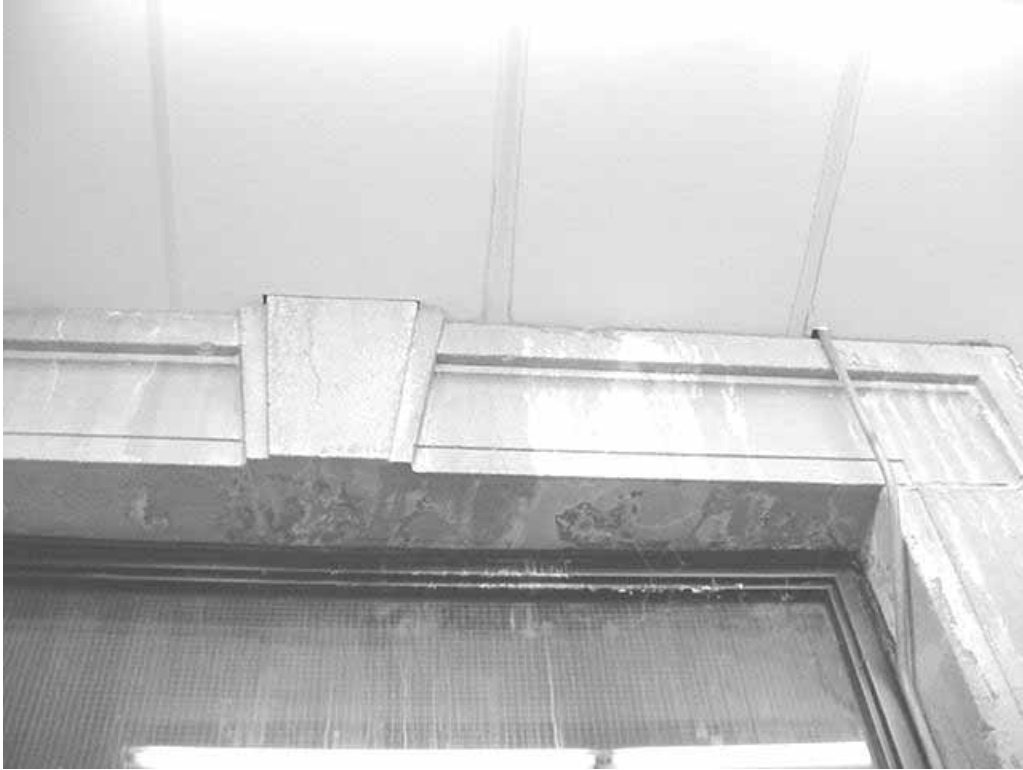
**Picture 8a**

**Water damage to ceiling tiles and door near adjoining building**

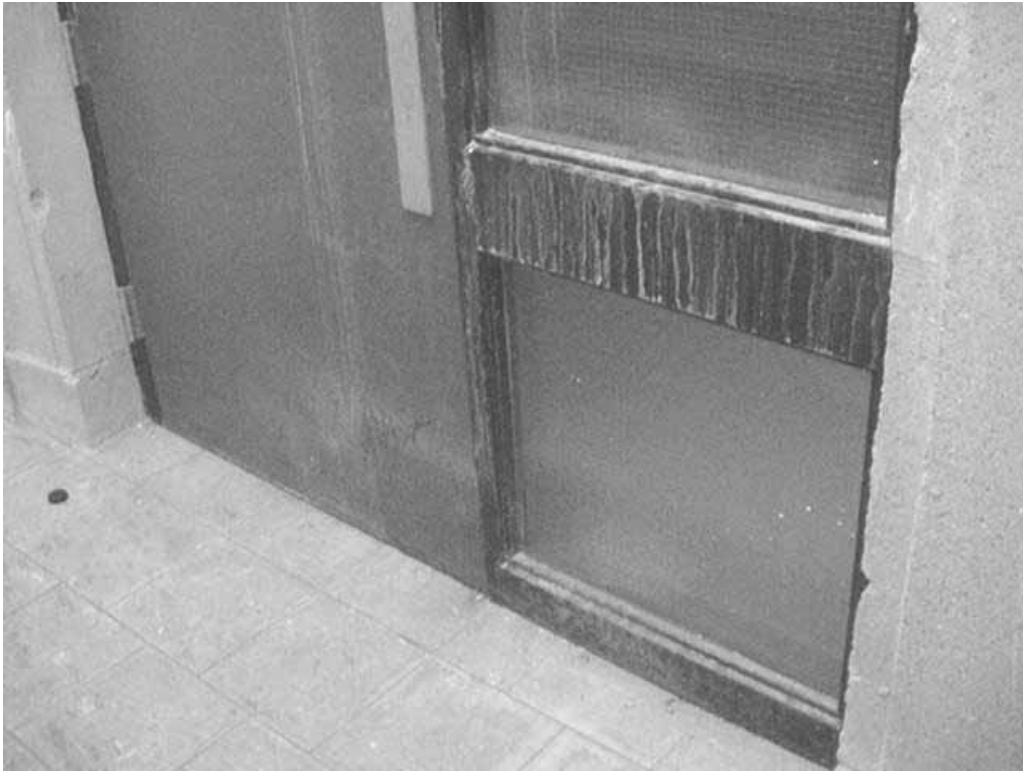
**Picture 8b**

**Water damage and efflorescence on door and floor**

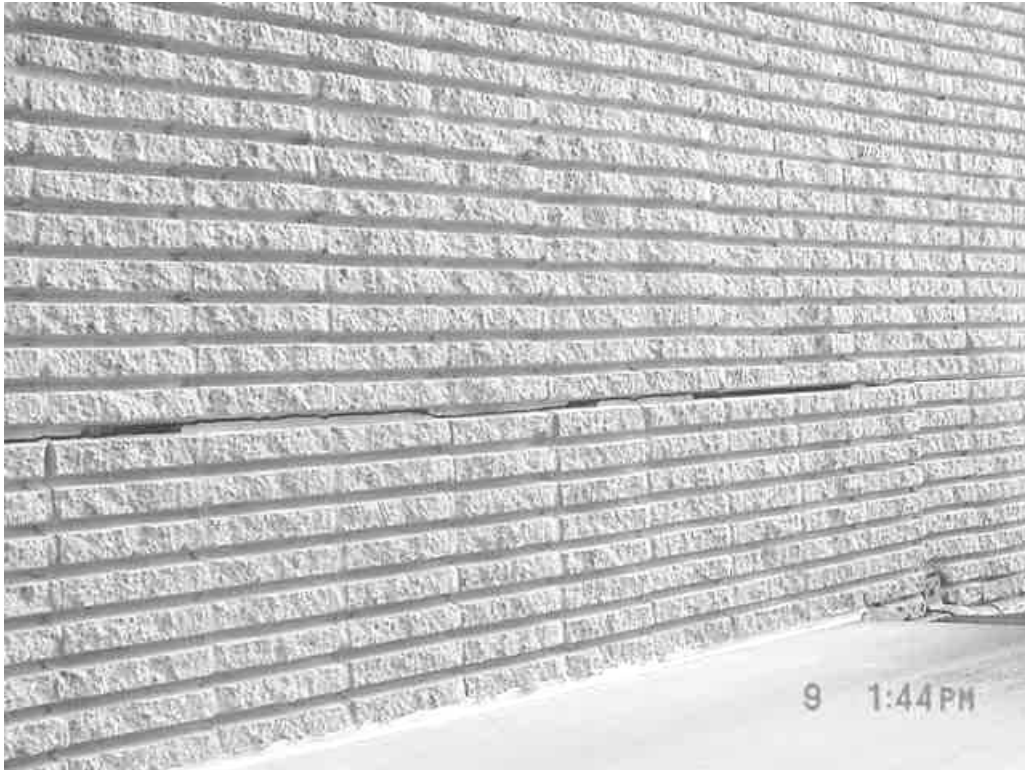
**Picture 9a**

Efflorescence on the interior of a building indicates that water is penetrating from the exterior (i.e. building envelope). BEHA staff examined the building exterior side of the art and computer storage rooms for points of water penetration. A large crack in the exterior wall was noted (Pictures 9a and 9b). Holes also remain in the brick exterior from previously existing banister (Picture 10). Breaches were also seen in and around a door (Pictures 11a, 11b, and 11c). Holes, breaches, and seams are points through which water can penetrate the building, particularly under driving rain conditions. These breaches were likely sources that provided water entry and resulted in damage to the art and computer storage rooms.

**Breach spanning a substantial length of the exterior wall**

1. Seal all holes and breaches along the exterior walls near the adjoining administration building.
2. Contact a roofing contractor or building envelope specialist to assess the integrity of the roof, especially the area between the PHCS and adjacent building.

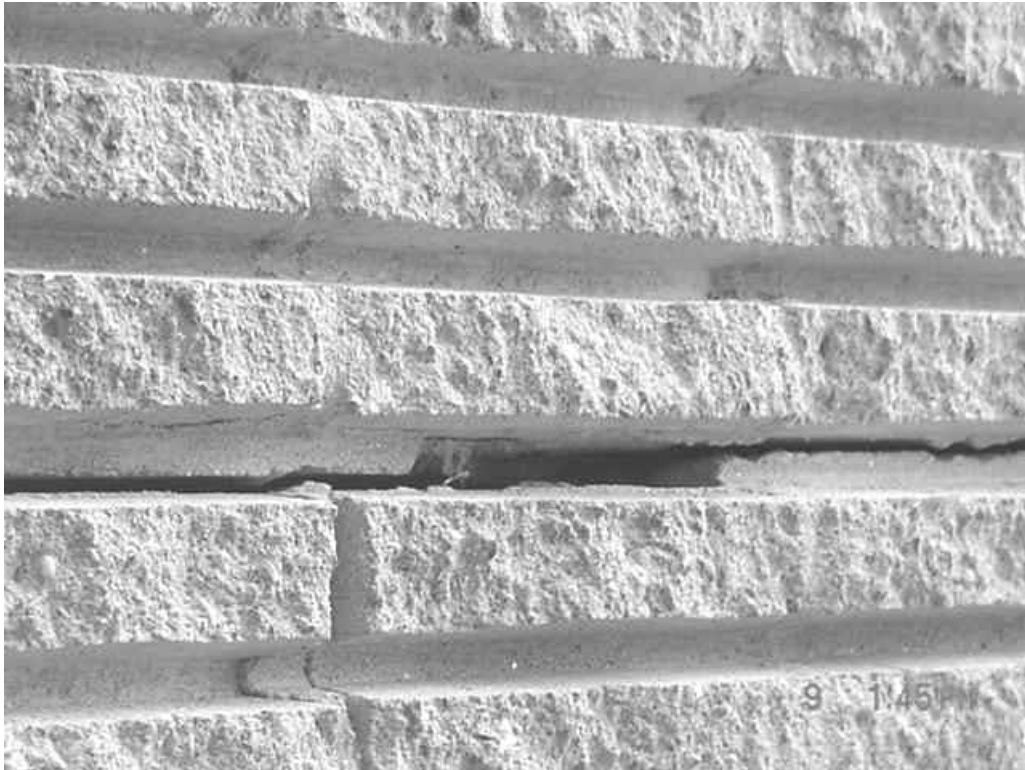
**Picture 9b**

**Close-up of breach in wall**

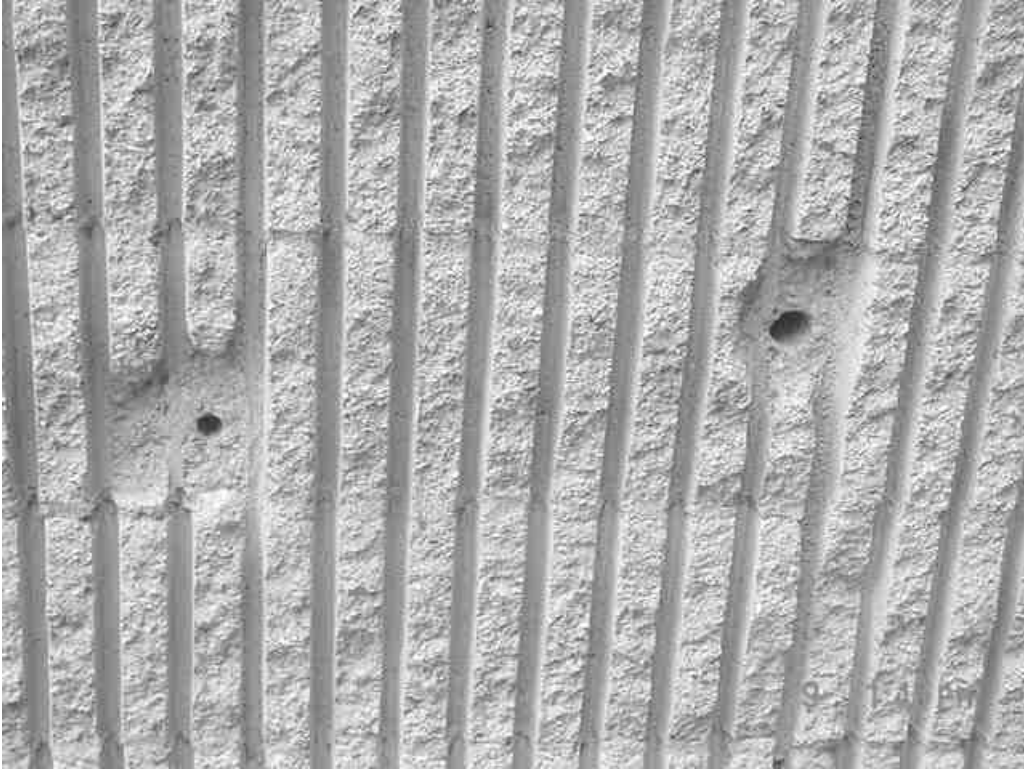
**Picture 10**

**Holes in wall from banister**

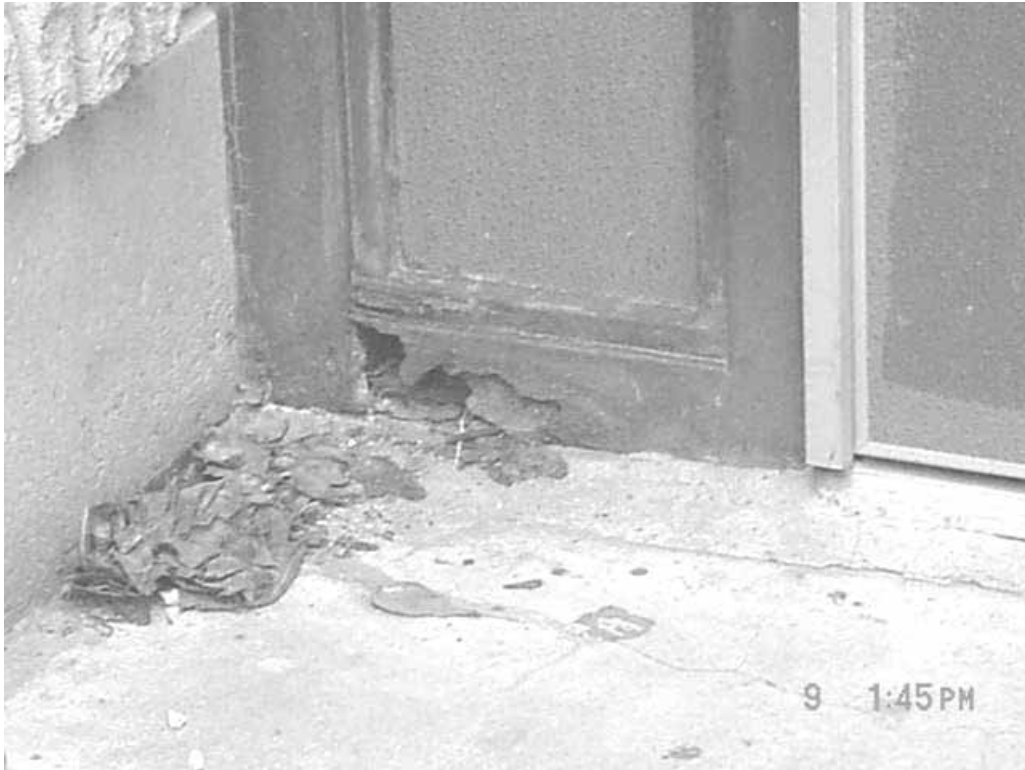
**Picture 11a**

**Corroded doorframe between PHCS and adjoining building**

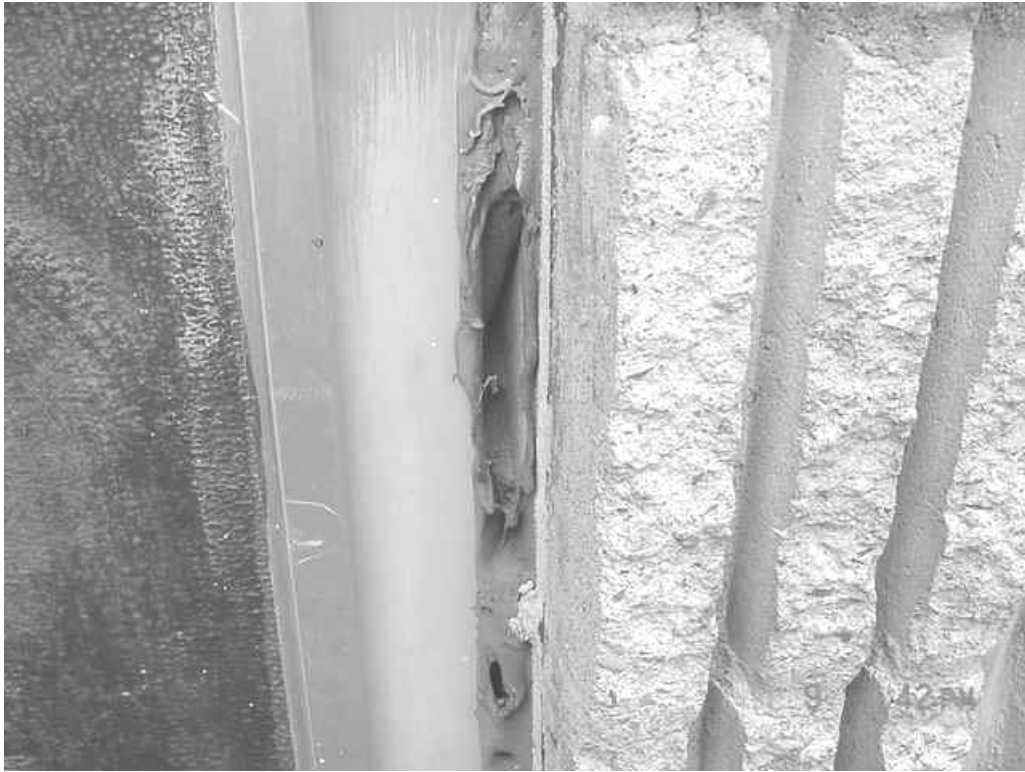
**Picture 11b**

**Damaged doorframe caulking**

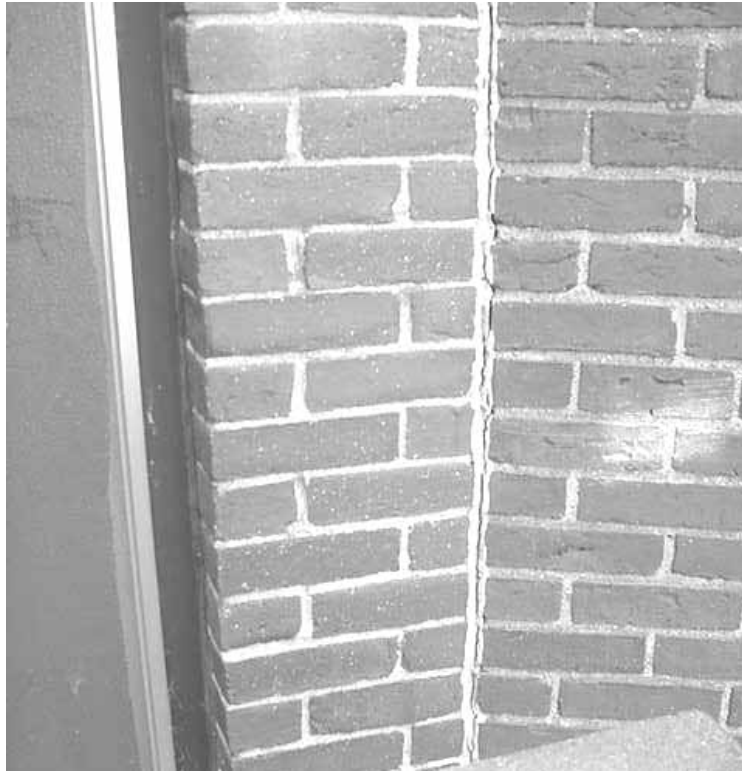
**Picture 11c**

**Seam in brick mortar**

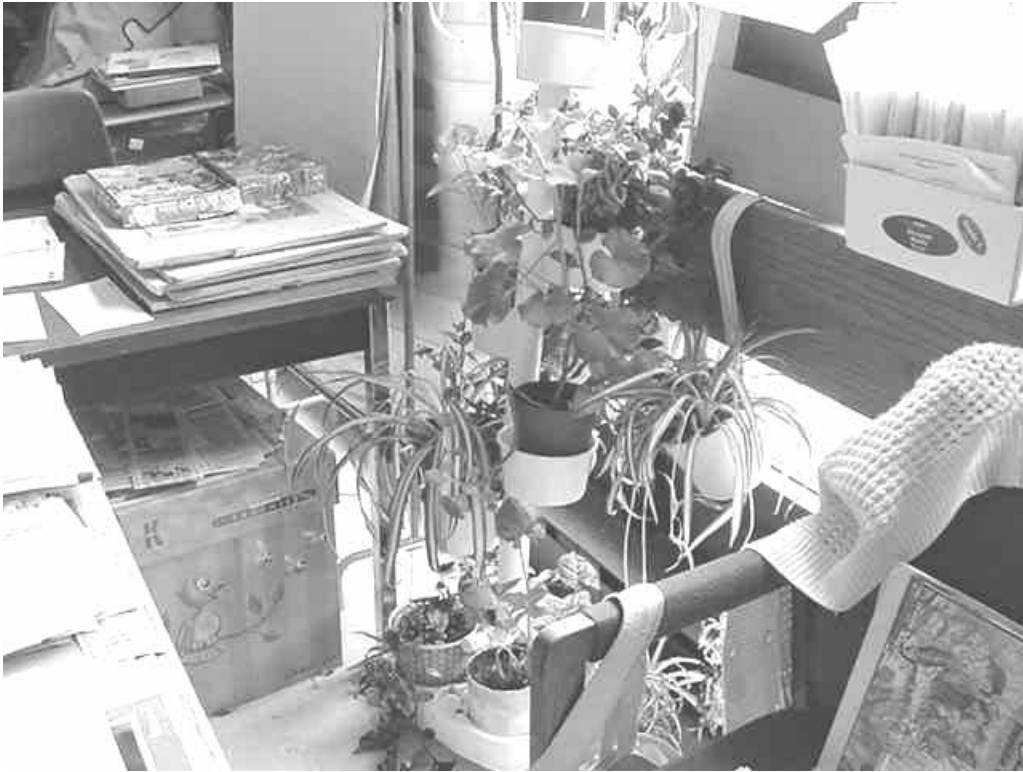
**Picture 12**

Plants were also observed in several classrooms (Picture 12). Plants, soil and drip pans can serve as sources of mold growth, thus should be properly maintained. Over-watering of plants should be avoided and drip pans should be inspected periodically for mold growth. Plants should also be located away from ventilation sources to prevent aerosolization of dirt, pollen or mold.

**Plants in classroom**

13. Ensure plants have drip pans. Avoid over watering and examine drip pans periodically for mold growth. Disinfect with an appropriate antimicrobial where necessary.

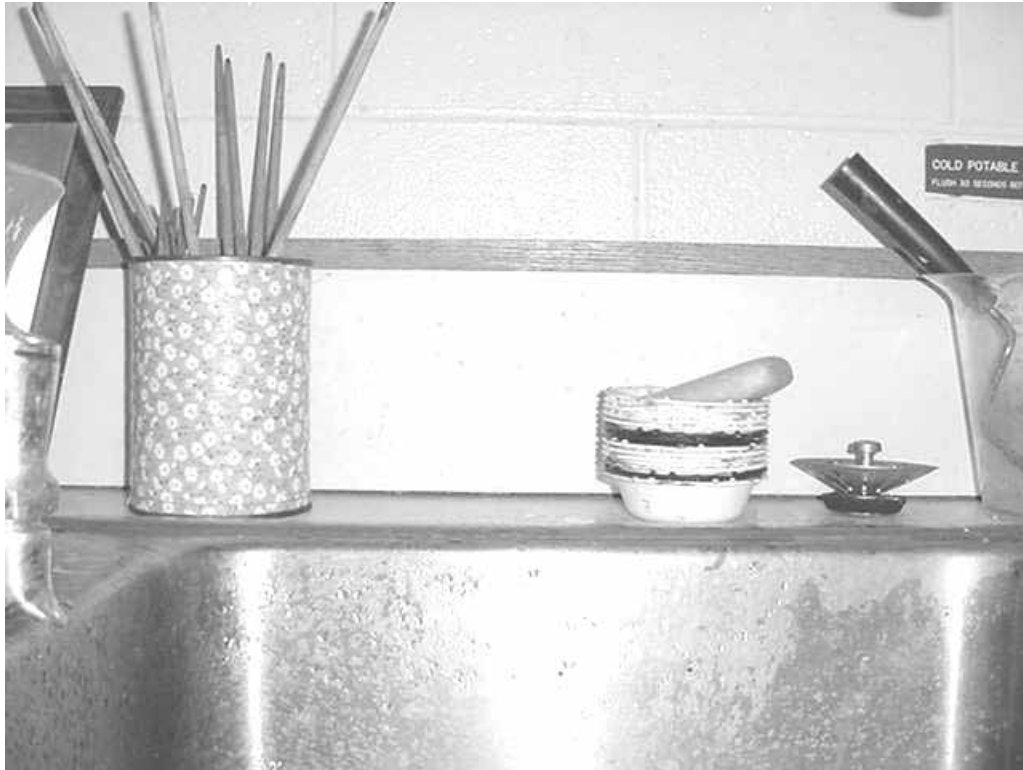
**Picture 13**

Open seams between the sink countertop and wall were observed in several rooms (Picture 13). If not watertight, water can penetrate through the seam, causing water damage. Water penetration and chronic exposure of porous and wood-based materials can cause these materials to swell and show signs of water damage. Moistened materials that are not dried within 24 to 48 hours can become potential sources for mold growth.

**Breach between sink and backsplash**

11. Place tile or rubber matting underneath water bubblers and refrigerator in carpeted areas.
12. Seal breaches, seams, and spaces between sink countertop and backsplash to prevent water damage.

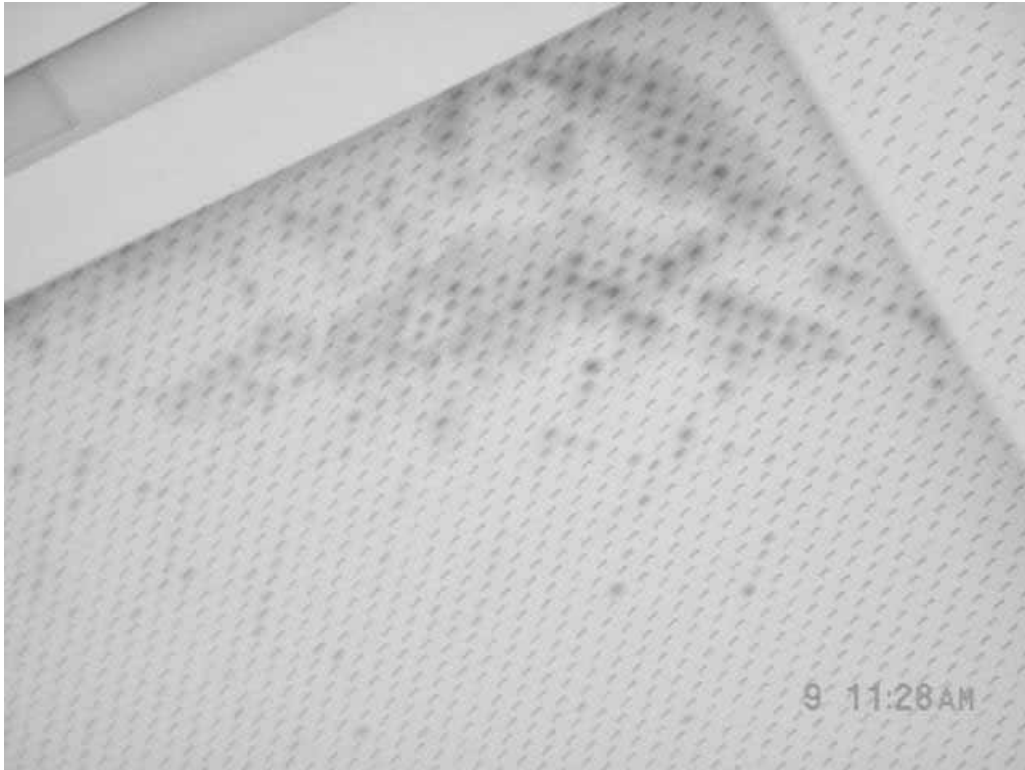
**Picture 14**

A few areas had water-damaged ceiling tiles, which can indicate leaks from the roof or plumbing system (Picture 14; Table 1). Water-damaged ceiling tiles can provide a source of mold and should be replaced after a water leak is discovered and repaired.

**Water damaged ceiling tile**

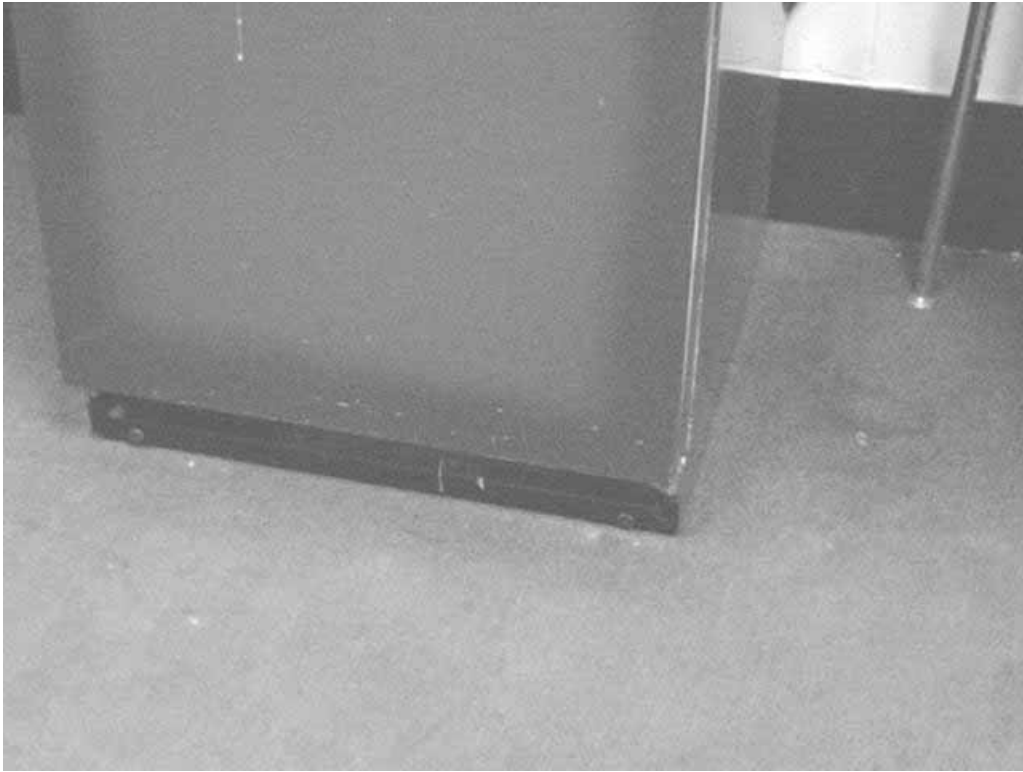
**Picture 15**

Lastly, a refrigerator is located on carpeted flooring (Picture 15). When warm, moist air passes over the cooling coils, condensation can form. Condensation is the collection of moisture on a surface at or below the dew point. The dew point is the temperature that air must reach for saturation to occur. Over time, condensation can collect and form water droplets. These water droplets can drip from the refrigerator on to the carpet. Moistened carpeting can also be a source of mold growth.

**Refrigerator on water damaged carpeting**

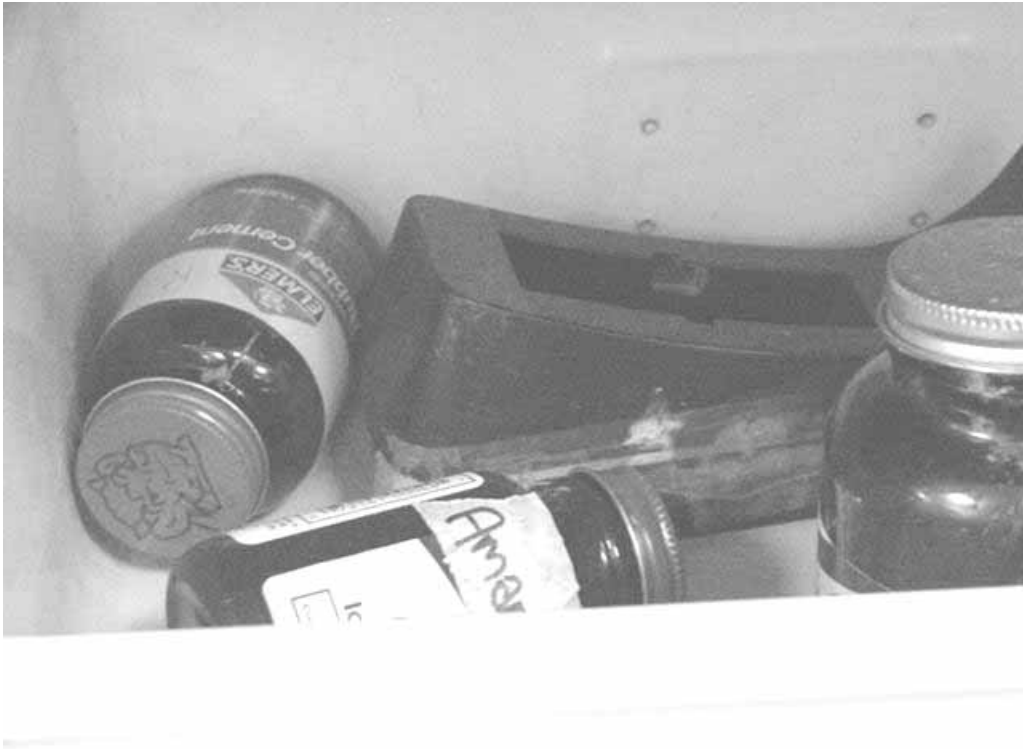
**Picture 16**

Several classrooms contained dry erase boards and dry erase board markers. Materials such as dry erase markers and dry erase board cleaners may contain VOCs, such as methyl isobutyl ketone, n-butyl acetate and butyl-cellusolve (Sanford, 1999), which can be irritating to the eyes, nose and throat. Spray paint canisters and rubber cement containers, which also contain VOCs, were noted (Picture 16). Rubber cement contains n-hexane or heptane, which can be irritating to the eyes, nose and throat. Local exhaust ventilation should be utilized when this material is used. As required by the federal Labeling of Hazardous Art Materials Act (LHAMA), art supplies containing hazardous materials that can cause chronic health effects must be properly labeled (USC, 1988). The use of such art supplies should be limited to times when students are not present and in areas where adequate exhaust ventilation is available. Rubber cement not only contains VOCs but also is flammable material. Rubber cement should be stored in a flameproof cabinet.

**Rubber cement stored in classrooms**

18. Clean exhaust/return vents periodically to prevent excessive dust build-up.
19. Discontinue use or ensure flammable products are stored in the proper cabinets.

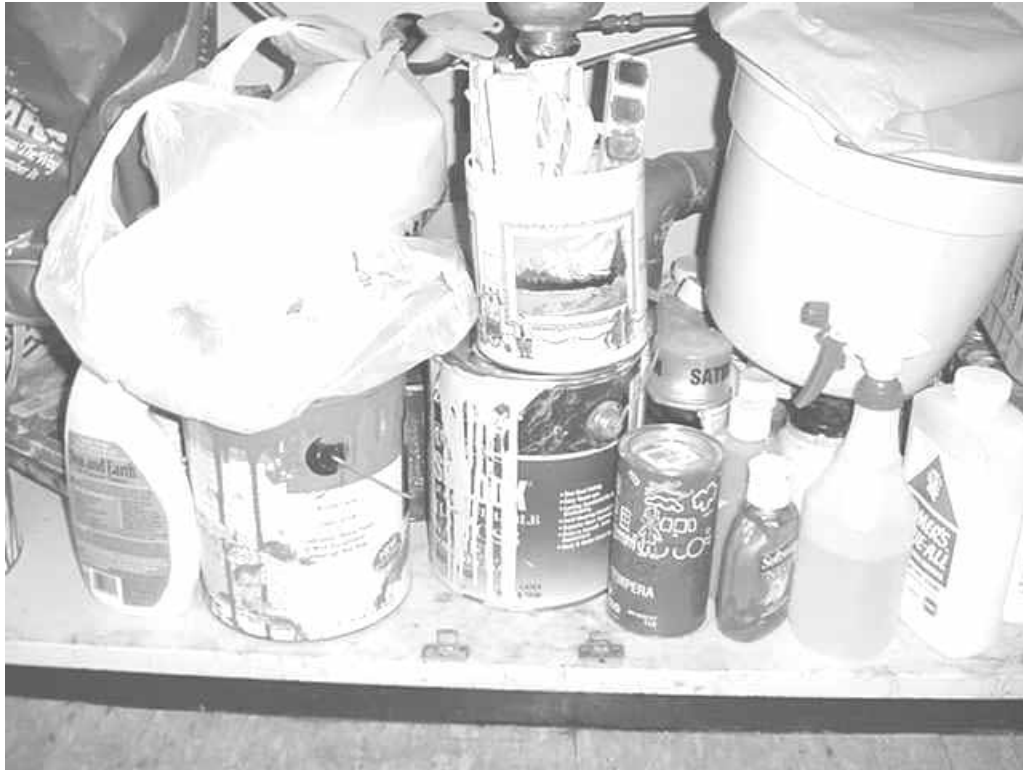
### Picture 17

Cleaning products were found on countertops and in unlocked cabinets beneath sinks in some classrooms (Picture 17). Like dry erase materials, cleaning products contain VOCs and other chemicals that can be irritating to the eyes, nose and throat of

sensitive individuals. Also of concern are unlabelled bottles and containers. Products should be kept in their original containers and be clearly labeled for identification purposes, especially in the event of an emergency.

**cleaning and paint products stored in an unlabeled cabinet**

16. Store cleaning products properly and out of reach of students. Ensure spray bottles are properly labeled.
17. Relocate or consider reducing the amount of materials stored in classrooms to allow for more thorough cleaning. Clean items regularly with a wet cloth or sponge to prevent excessive dust build-up.

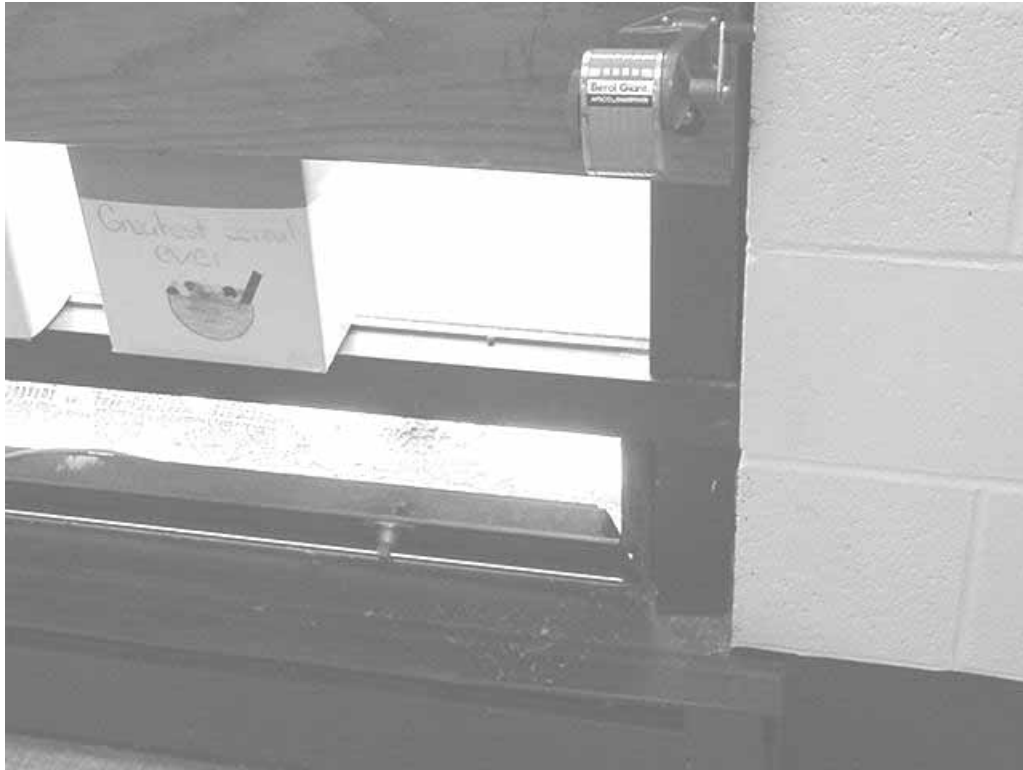
**Picture 18**

Accumulated chalk dust was noted in some classrooms. Chalk dust is a fine particulate that can easily become aerosolized, irritating eyes and the respiratory system. Similarly, pencil shavings were observed to be accumulating at the base of pencil sharpeners (Picture 18). Open windows and operating ventilation can aerosolize chalk dust and pencil shavings.

**Pencil sharpener located above an open window**

14. Clean chalkboards and dry erase board trays and pencil sharpeners regularly to avoid build-up of particulates.
15. Relocate pencil sharpeners away from windows.

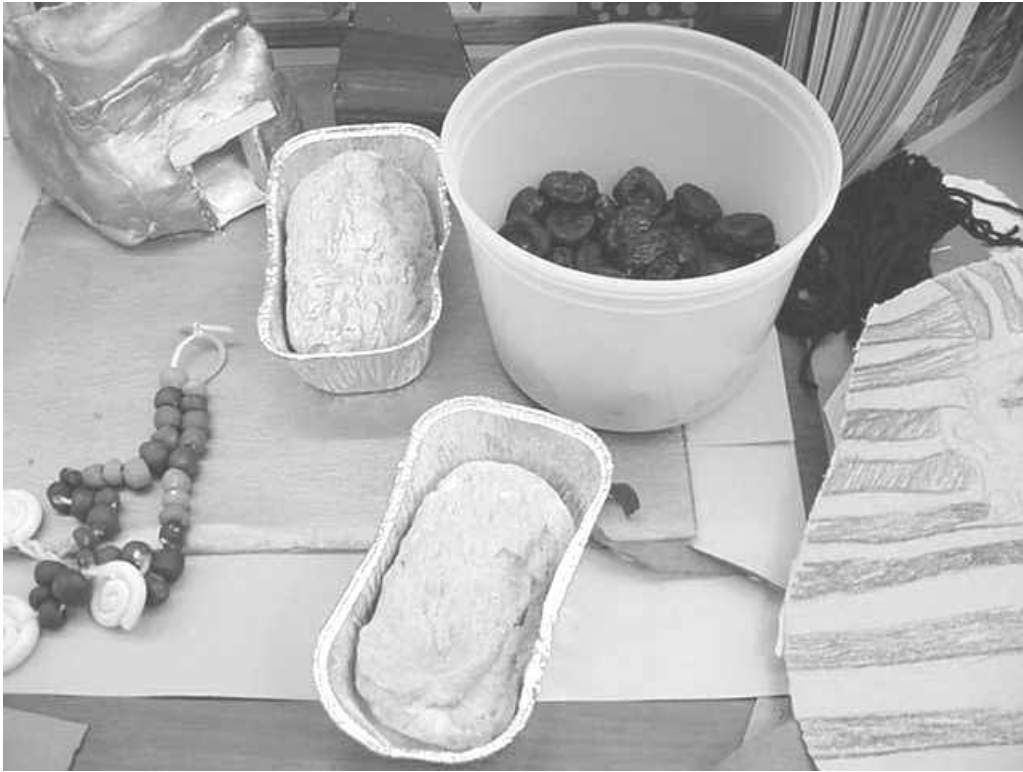
**Picture 19**

As discussed, conditions that attract pests should be reduced/eliminated. Food is an attractant to pests and rodents (e.g. food open areas (Picture 19)). Proper food storage is an integral component in maintaining indoor air quality. Food should be properly stored and clearly labeled. Reuse of food containers (e.g. for art projects) is not recommended since food residue adhering to the container surface may also serve to attract pests.

**Food stored openly in classrooms**

- c) Store foods in tight fitting containers.
  - d) Avoid eating at work stations. In areas where food is consumed, vacuum periodically to remove crumbs.

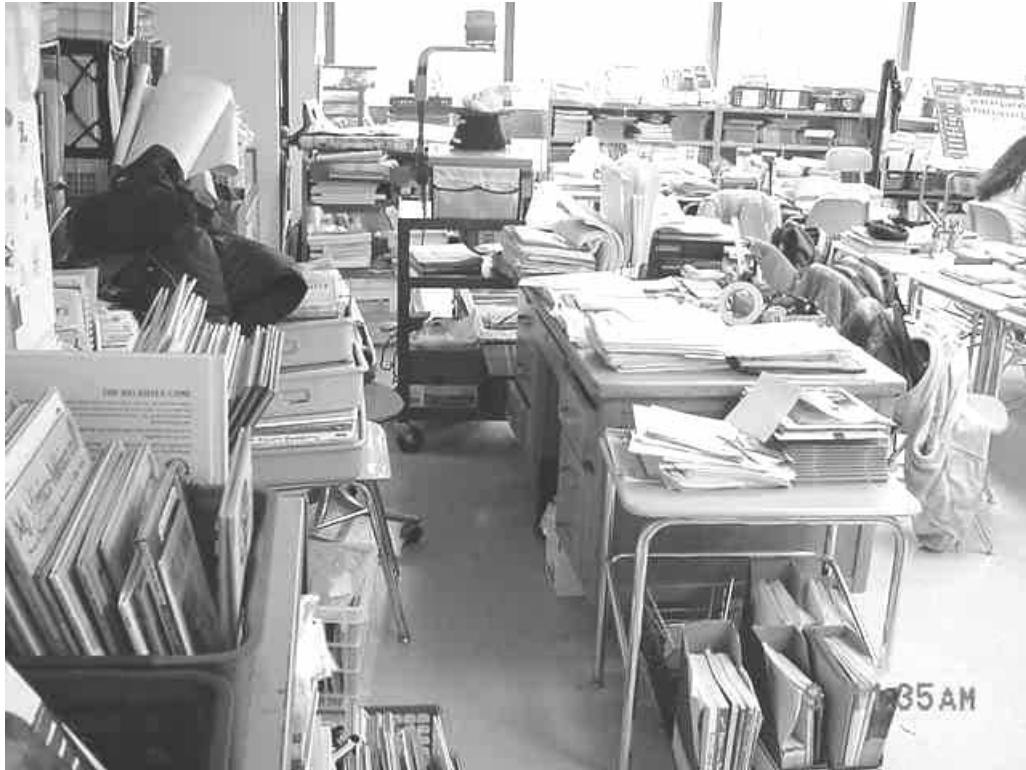
**Picture 20**

Also of note was the amount of materials stored inside classrooms (Picture 20). In classrooms throughout the school, items were seen on windowsills, tabletops, counters, bookcases and desks. The amount of items stored in classrooms provides a means for dusts, dirt and other potential respiratory irritants to accumulate. Many of the items, (e.g. papers, folders, boxes) make it difficult for custodial staff to clean. The age of stored materials should also be considered. A large collection of older periodicals and other art supplies were noted in the art room.

**Accumulated items in classrooms**

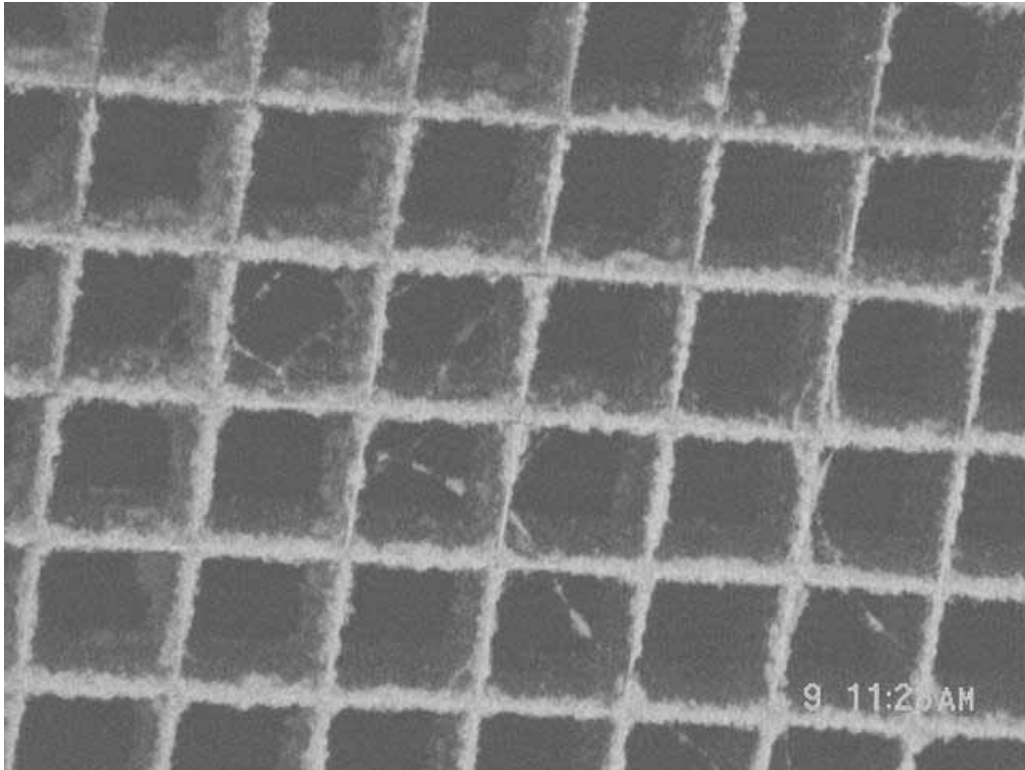
**Picture 21**

Dust was noted accumulated on many surfaces. A number of exhaust vents in classrooms were also noted with accumulated dust (Picture 21). Back drafts can result in re-aerosolization of accumulated dust particles. Dust can be irritating to the eyes, nose and respiratory tract.

**Dust accumulated on exhaust vent**

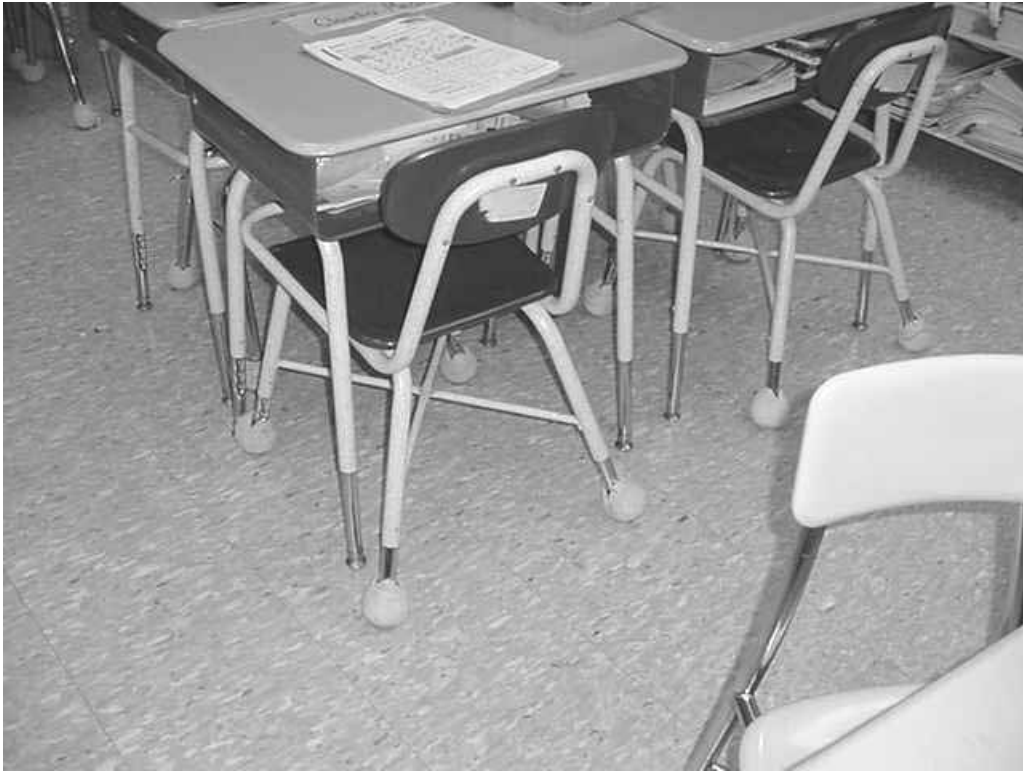
**Picture 22**

In an effort to reduce noise from sliding chairs, tennis balls had been spliced open and placed on chair legs (Picture 22). Tennis balls are made of a number of materials that are a source of respiratory irritants. Constant wearing of tennis balls can produce fibers and off gas VOCs. Tennis balls are made with a natural rubber latex bladder, which becomes abraded when used as a chair leg pad. Use of tennis balls in this manner may introduce latex dust into the school environment. Some individuals are highly allergic to

latex (e.g., spina bifida patients) (SBAA, 2001). It is recommended that the use of materials containing latex be limited in buildings to reduce the likelihood of symptoms in sensitive individuals (NIOSH, 1997). A question and answer sheet concerning latex allergy is attached as Appendix B (NIOSH, 1998).

**Tennis balls on chair legs**
